DIY Astronomy

Telescope Mount Improvements

Doug Holland

Mount to be improved: Losmandy G11

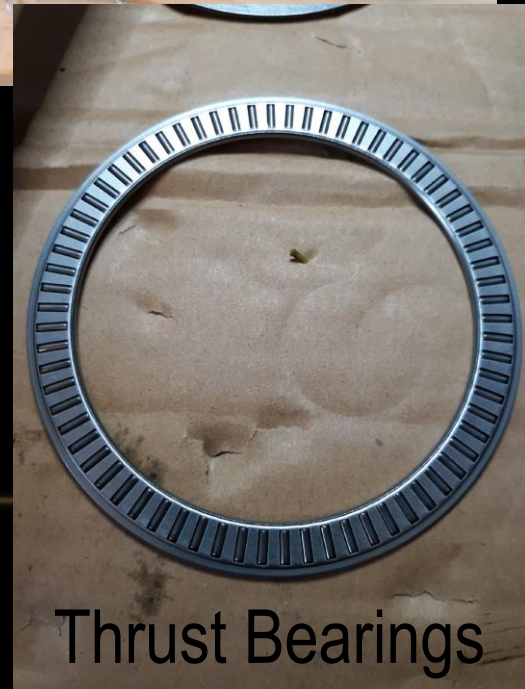
Thrust bearings gummed up with old lubricant – causing stiction

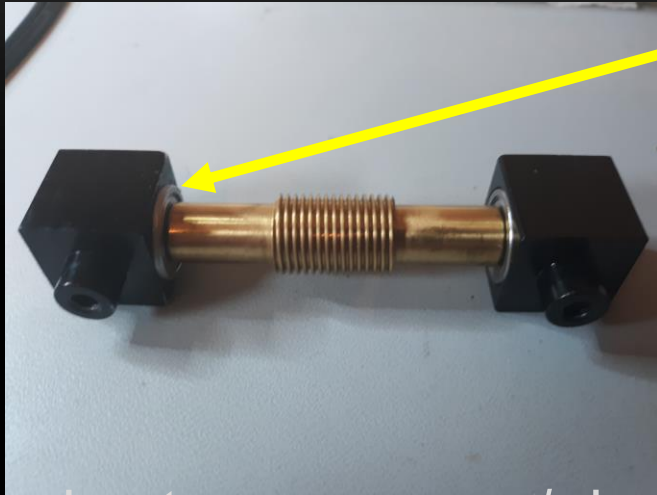
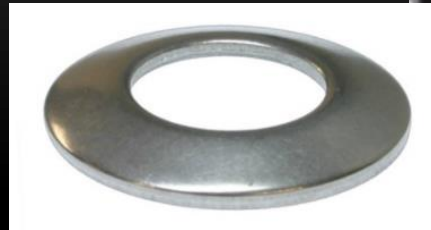
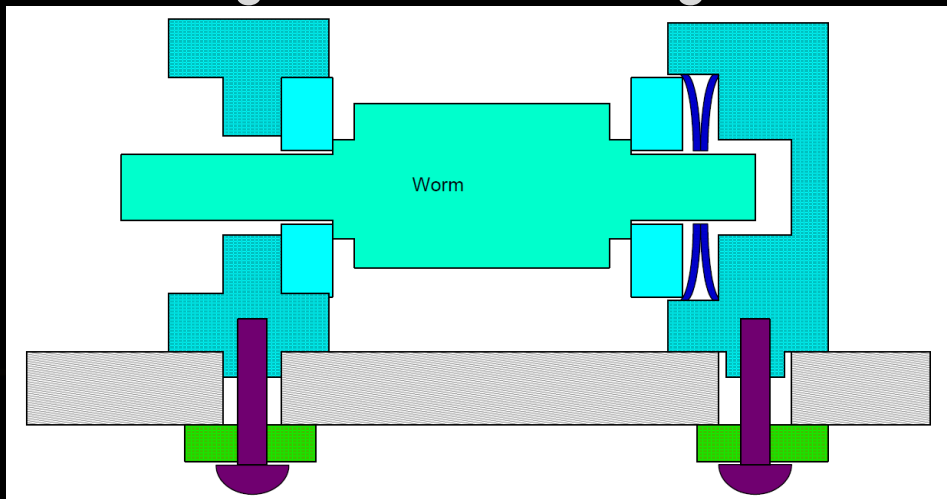
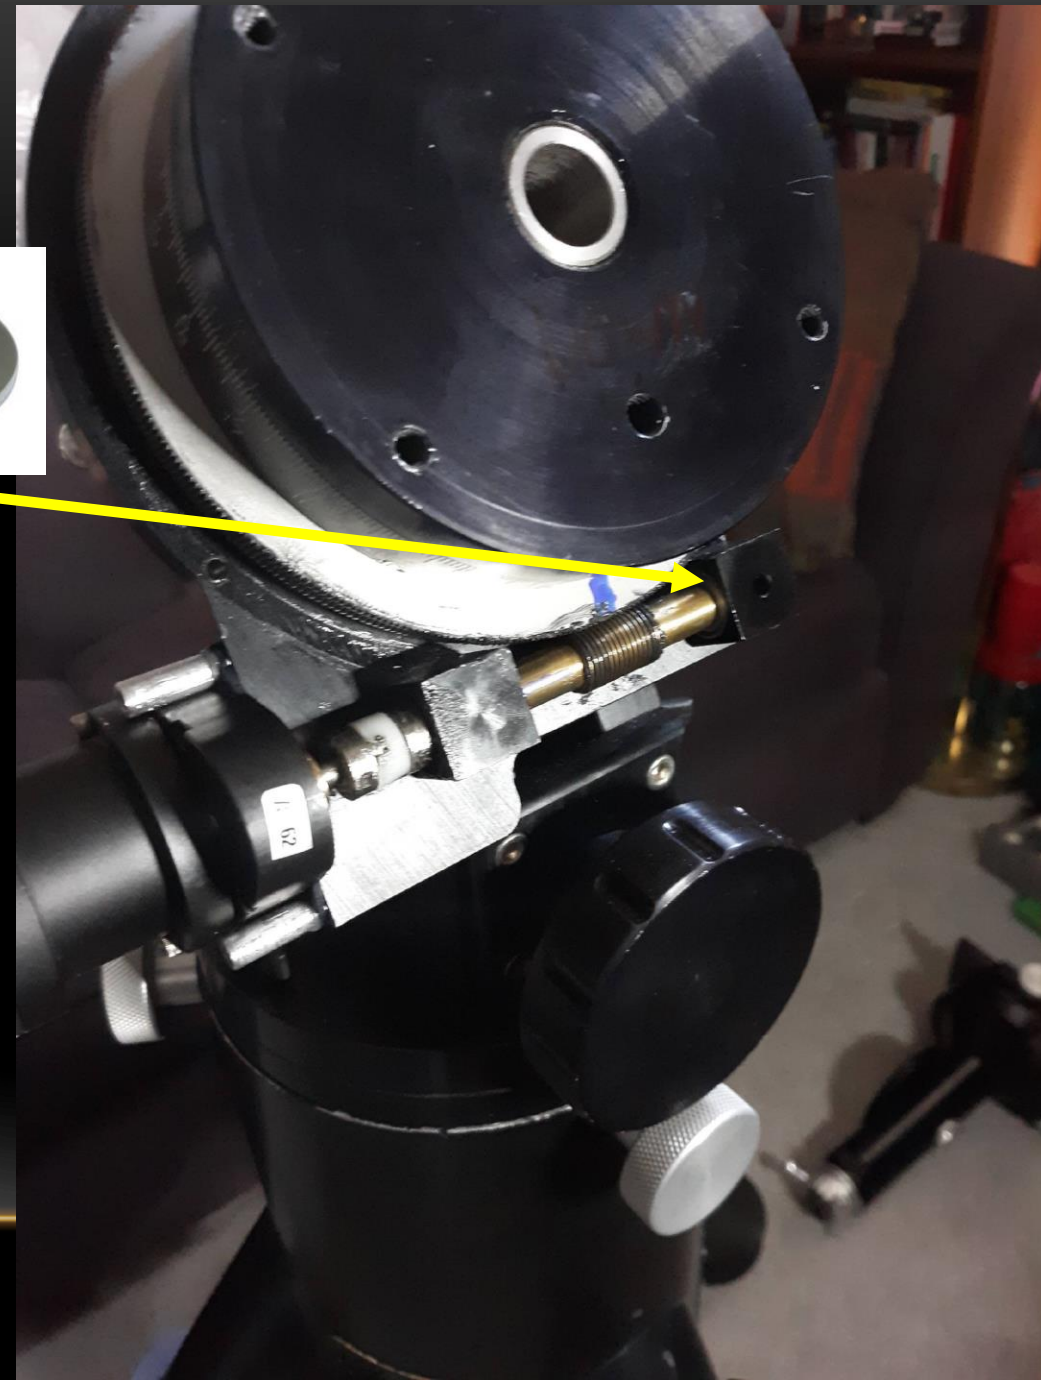
Applies tension to worm gear / ring gear interface.
Keeps worm gear from moving back & forth.

3. Added Belleville Washer to Bearing Block

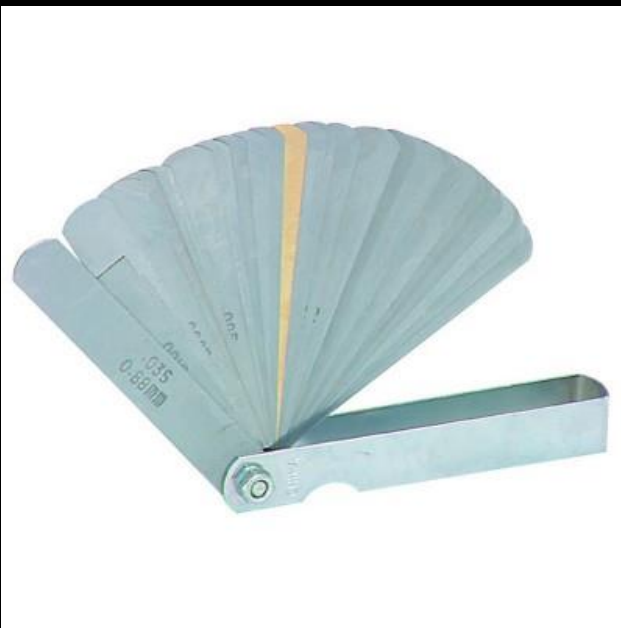
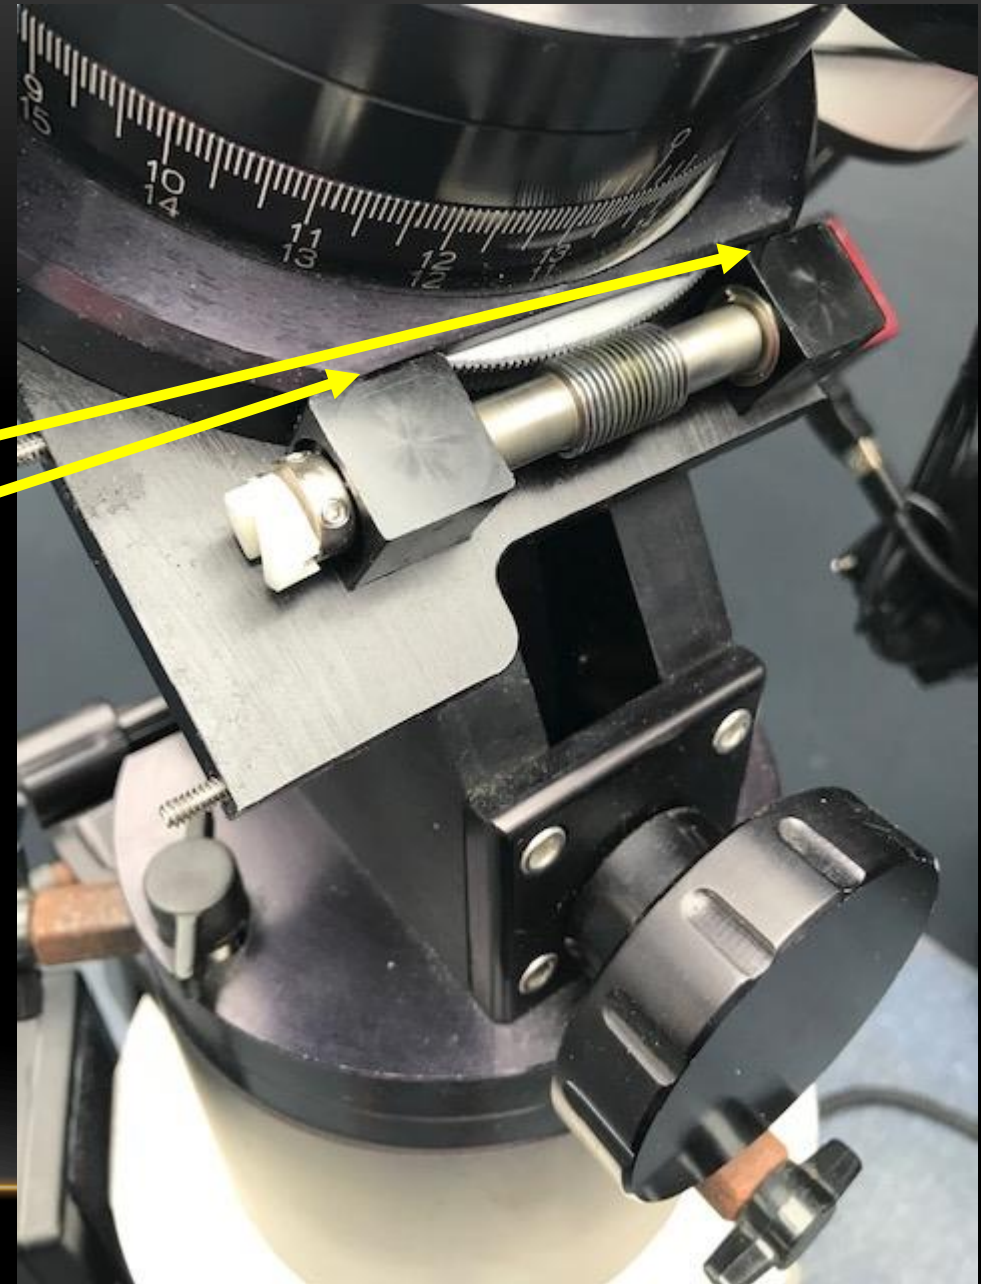
Gap Gauge / Feeler Gauge

Right Bearing Block
moves more than left

In end – Worm Gear should
move smoothly, but no play
/ backlash.

5. Set gap between Worm Gear & Ring Gear

=> Use gap gauge to set Bearing Blocks

* Reduce backlash

* Being too tight thus stalling motor
(RA Motor Lags message)

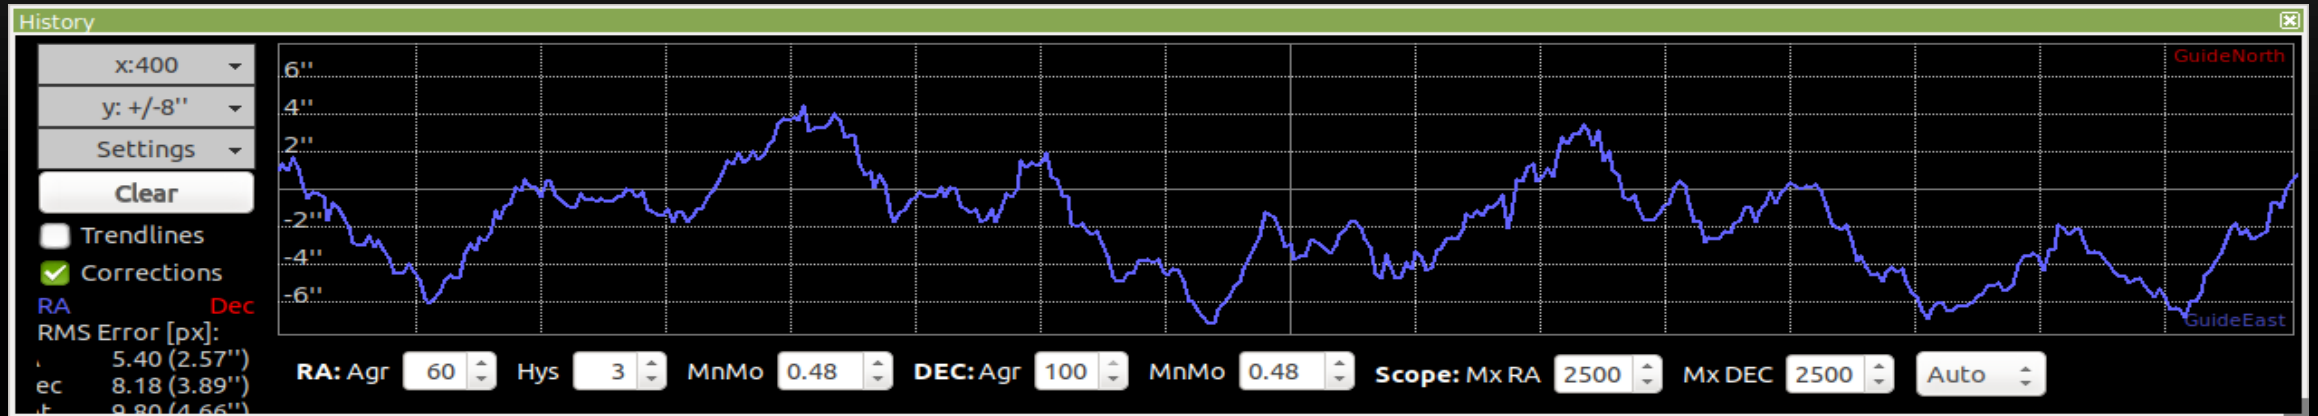
Before – Approx. 11" peak to peak periodic error.

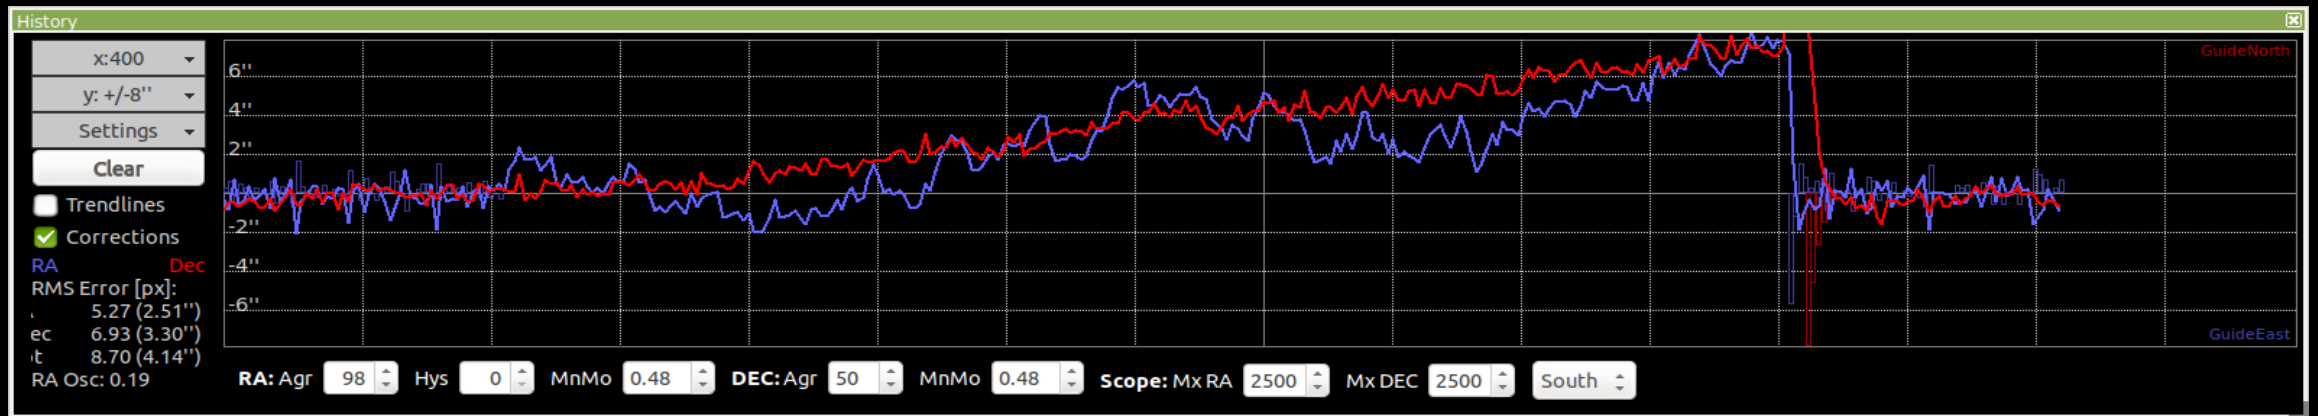
After – Approx. 4" peak to peak periodic error. (Ignoring drift)

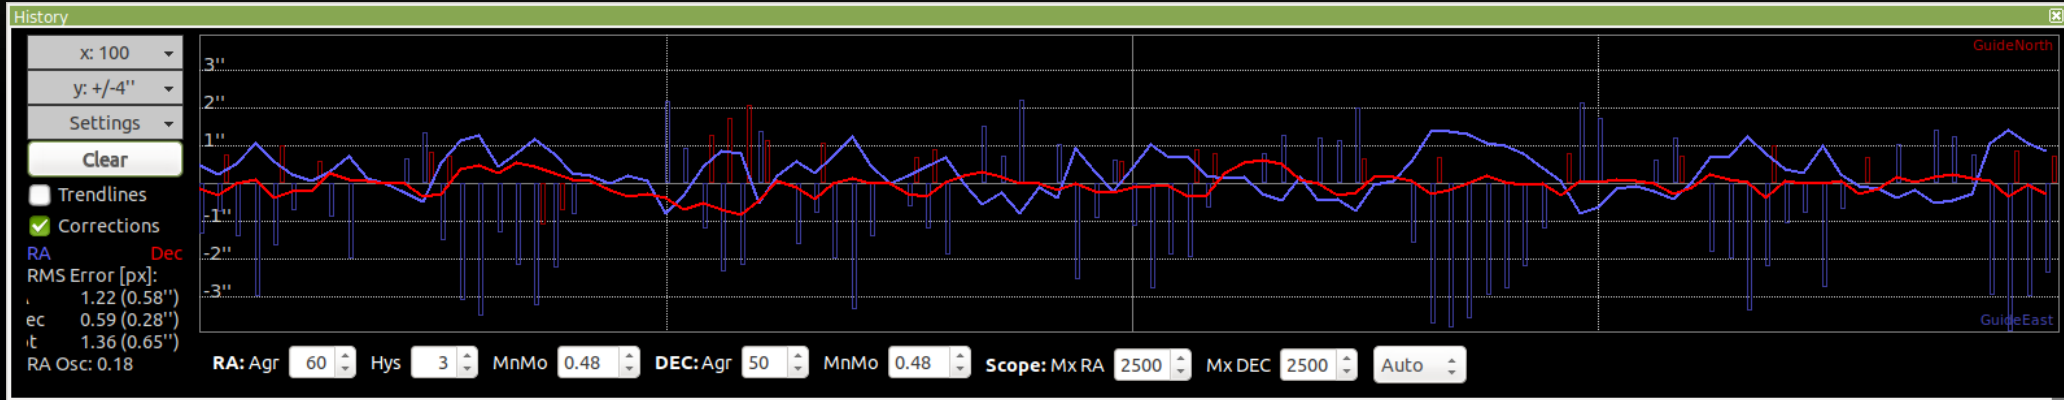
ST4 / Autoguiding Port: 0.58" RMS error

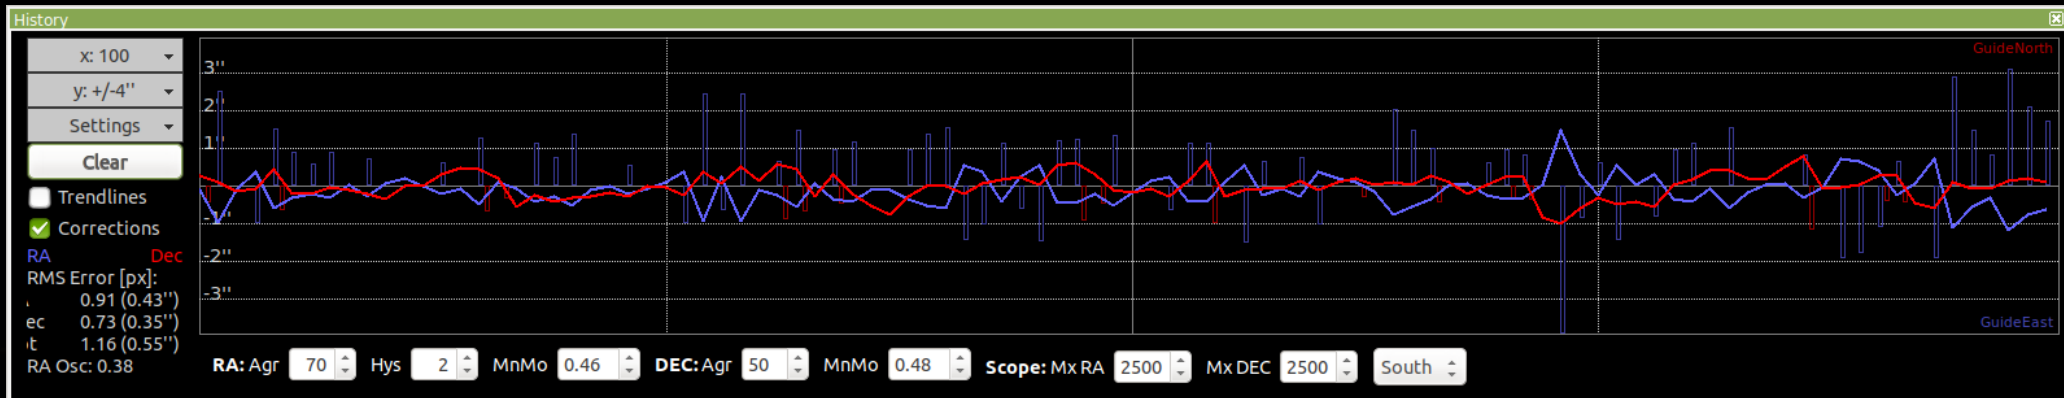
Pulse Guiding / RS232 Port: 0.43" RMS error
