G11 RA PE Improvement

5/6/21

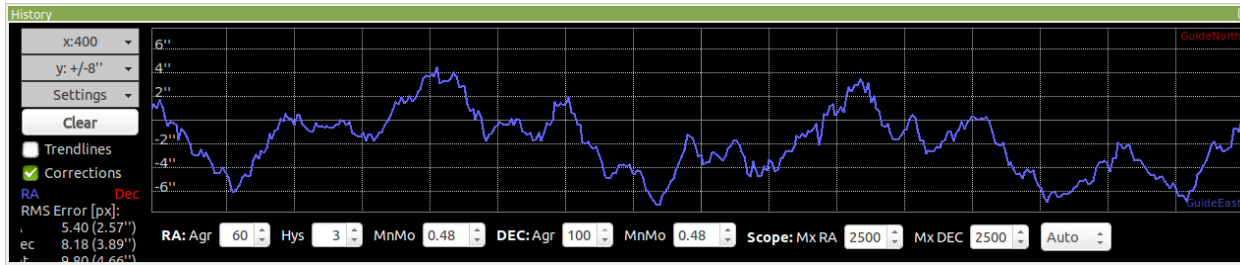
Prior to modifications

1/2/21 Test - Approx. 11"pp, large jags

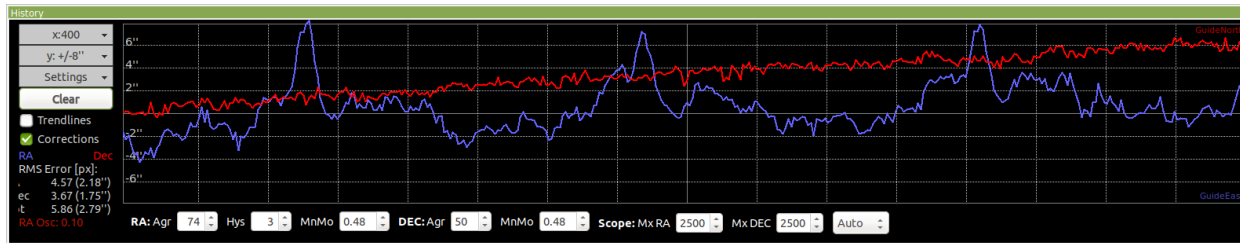
4/10/21 Test - Approx. 11"pp, pulse every 4 minutes

After 1st round of modifications - New bearing blocks, replaced bearings (all new Losmandy), regreased worm & worm gear with Tungsten Disulfide & Superlube, added 1 Belleville washer, new Oldham coupler (compressed), aligned motor, RA right bearing gap set to 0.039", regreased entire DEC axis and replaced Oldham coupler, DEC right bearing gap set to 0.030"

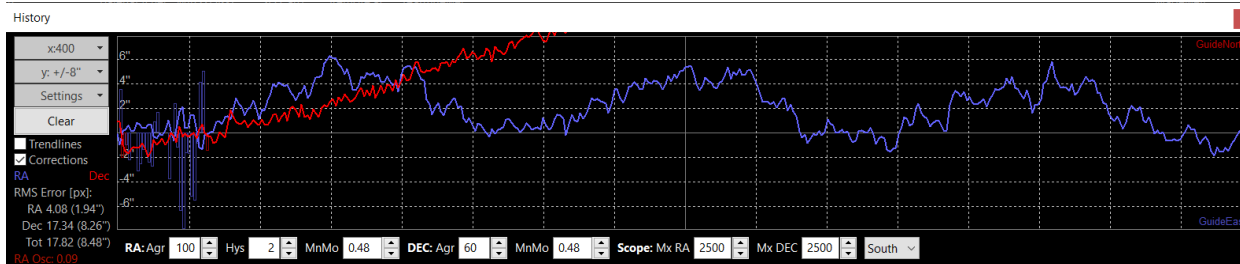
4/21/21 Test - Approx. 6"pp, RA Motor Lags message

After 2nd round of modifications - Replaced new left bearing block (new left bearing block causing worm to be too close to ring gear) near motor with old block, replaced left bearing with new Boca bearing, right bearing still new Losmandy, still 1 Belleville washer, relubed bottom part of axis components near captain tightening knob, improved alignment of motor, RA right bearing block 0.032", left 0.028", found best areas on ring gear and marked CWD position on ring gear

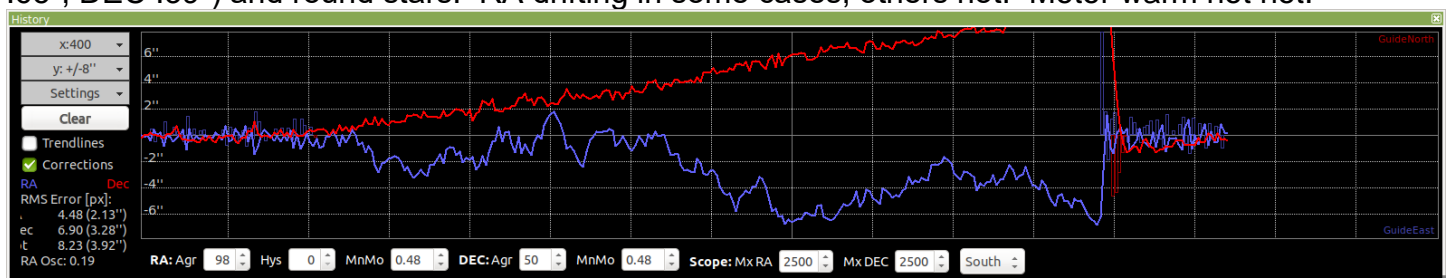
4/24/21 Test – Approx. 6" pp, RA Motor Lags message. Very good autoguiding results (approx. RA .65", DEC .39") and round stars. RA drifting in some cases, others not. Motor warm not hot.

After 3rd round of modifications – Set RA bearing blocks: right 0.035", left 0.030"; loosened Oldham coupler and applied Superlube on outside hoping to get some on inside.

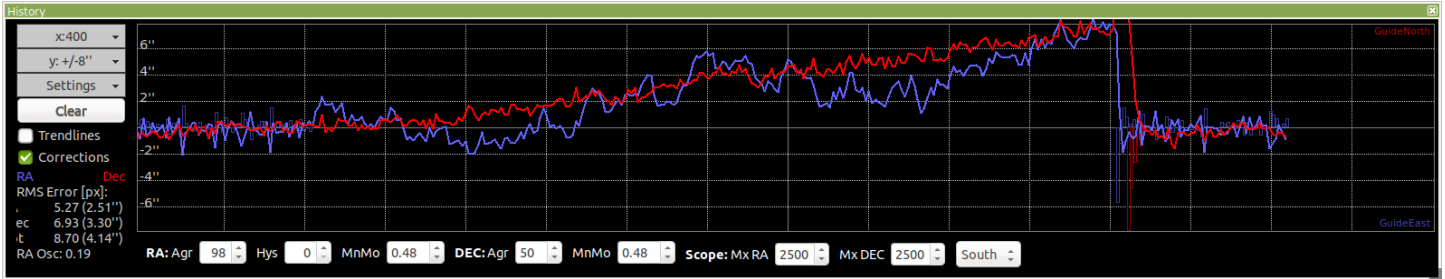
5/6/21 Test – Approx. 4" pp but with drift following DEC, did not see RA Motor Lags message. Very good autoguiding results (approx. RA .59", DEC .60") and round stars. Motor cooler than previous.

After 4th round of modifications – After disassembly found worm to be turning easily. Theory that mount worked out whatever problem it had during last use. Greased inside of Oldham Coupler, aligned motor and put wires in filed out motor mounting holes to keep motor from moving, cleaned RA clutch teflon plate and interfaces.
