DIY Astronomy

Telescope Mount Improvements

Doug Holland

Mount to be improved: Losmandy G11

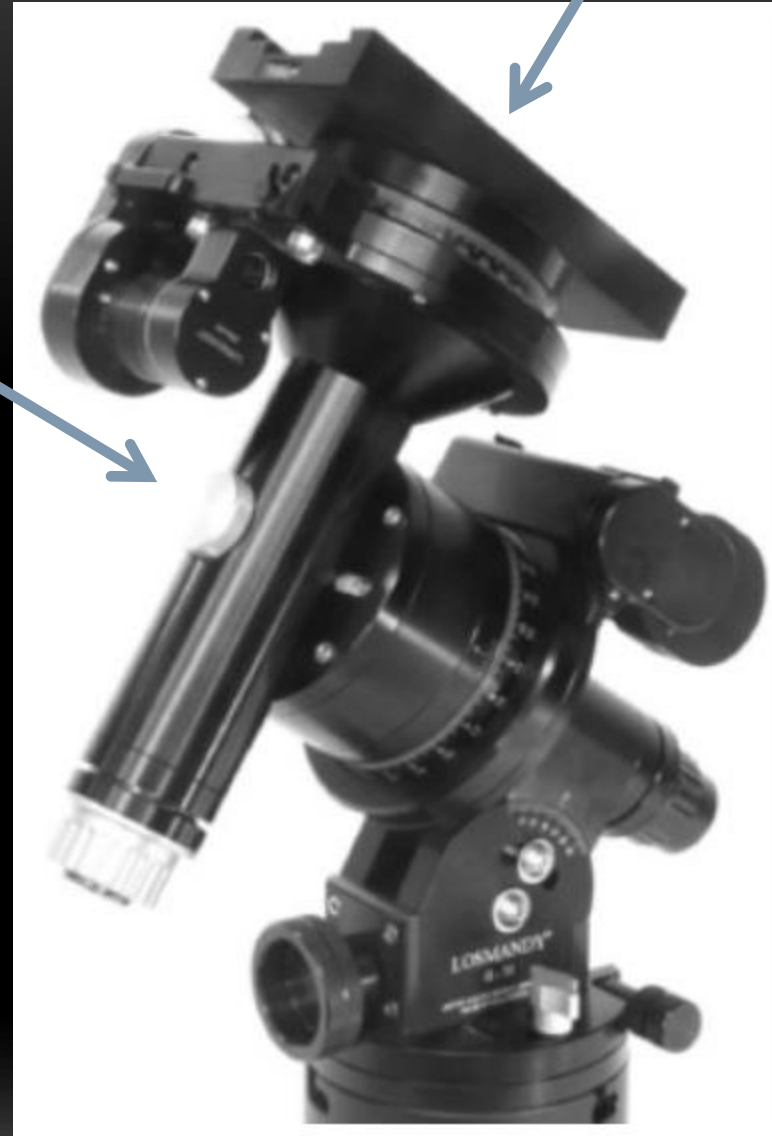
Issues –

DEC: Stiction (static friction)

=> Jerkiness during movement

RA: Periodic Error

=> Elongated stars, smeared images

Mount built in 2005, purchased used in 2010.

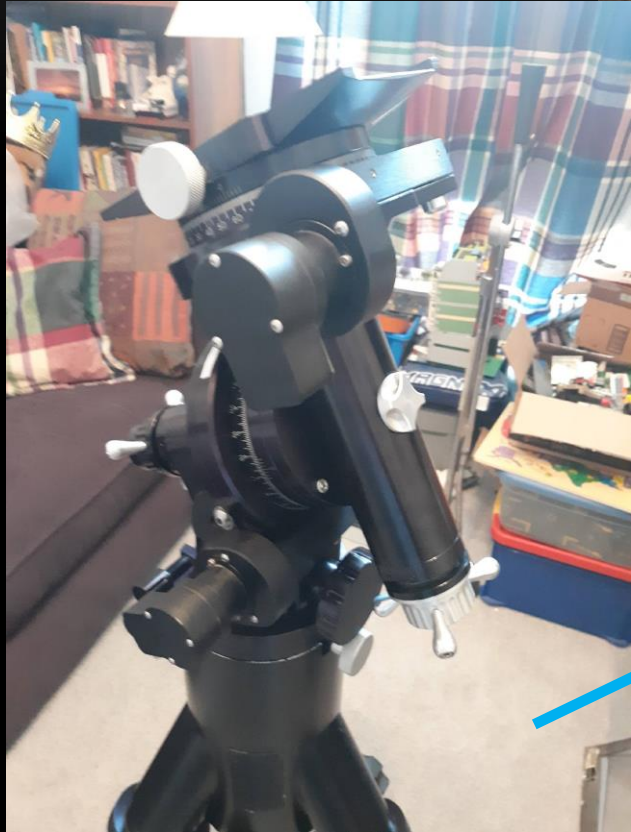
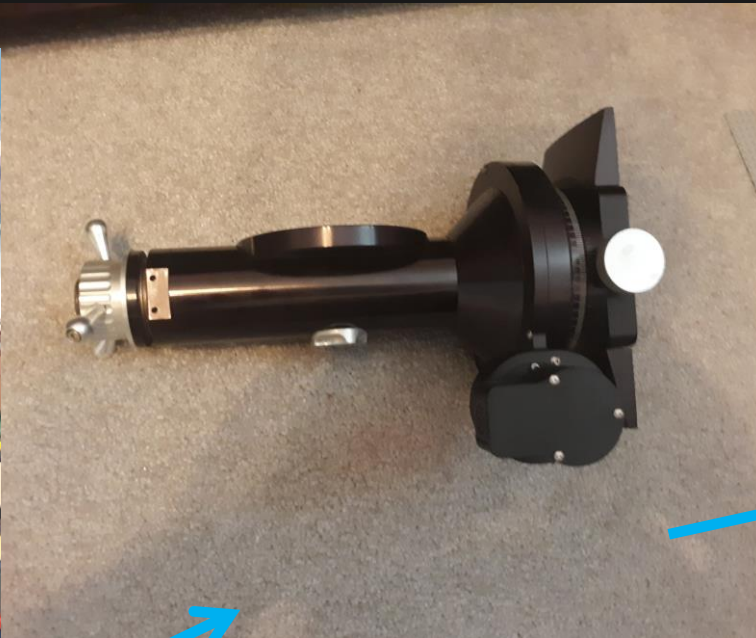
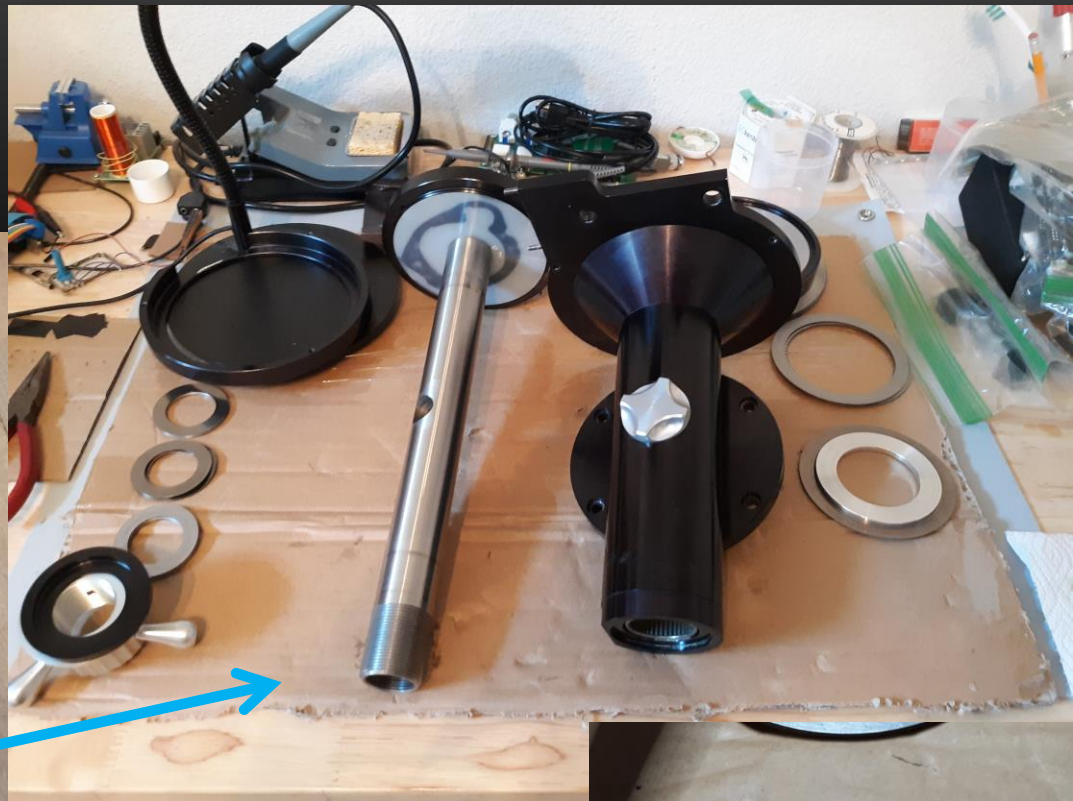
DEC: Stiction (static friction)
=> Jerkiness during movement

Thrust bearings gummed up with old lubricant – causing stiction

Disassemble

Remove DEC axis

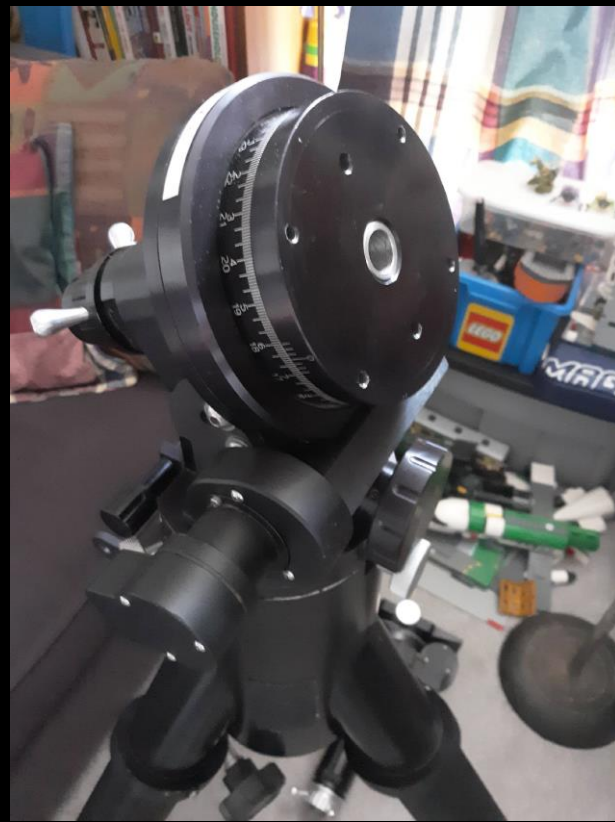
RA axis with DEC axis removed

Oldham Coupler
Couples Gear Box
to Worm Gear

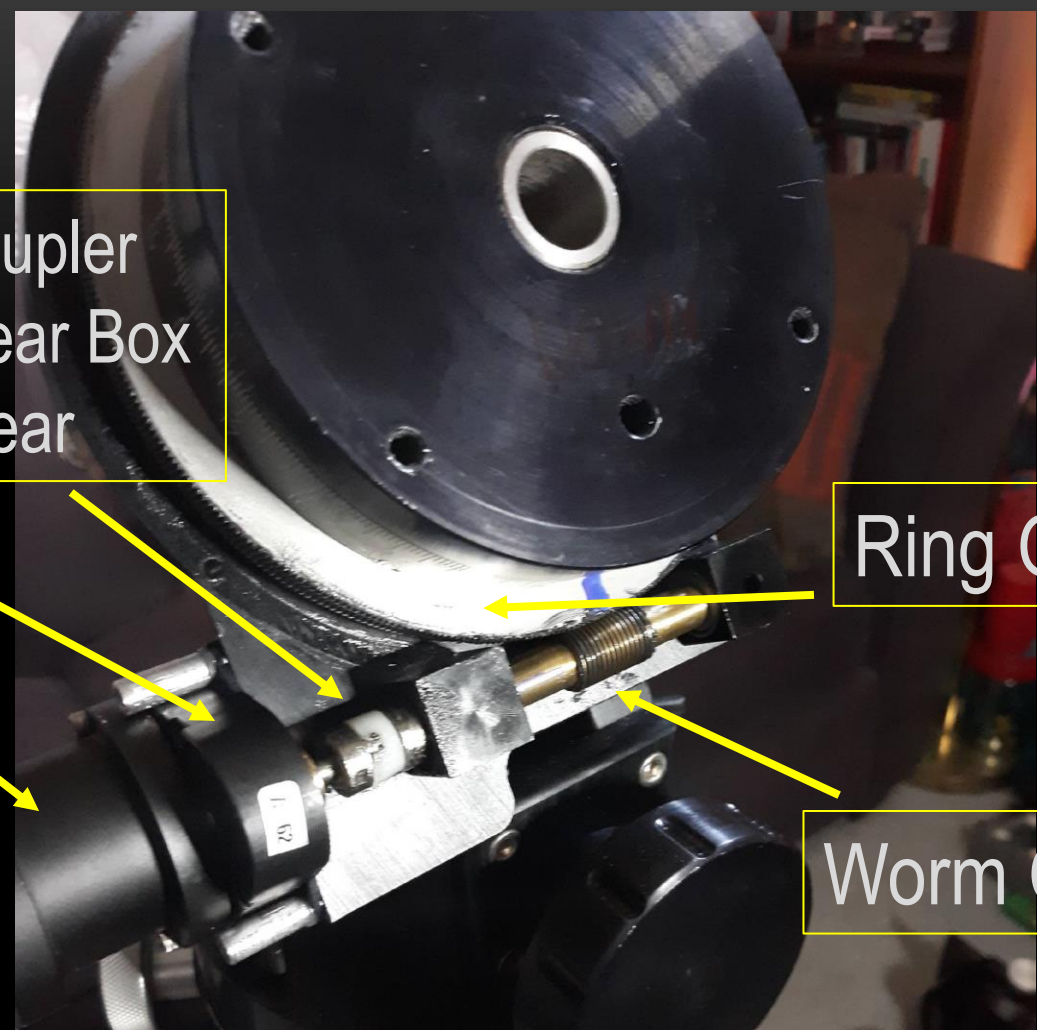
Periodic Error – Changes in rate of RA axis rotation due to imperfections in Worm Gear & associated mechanism. Repeats once per rotation of Worm Gear (e.g. 4 minutes).

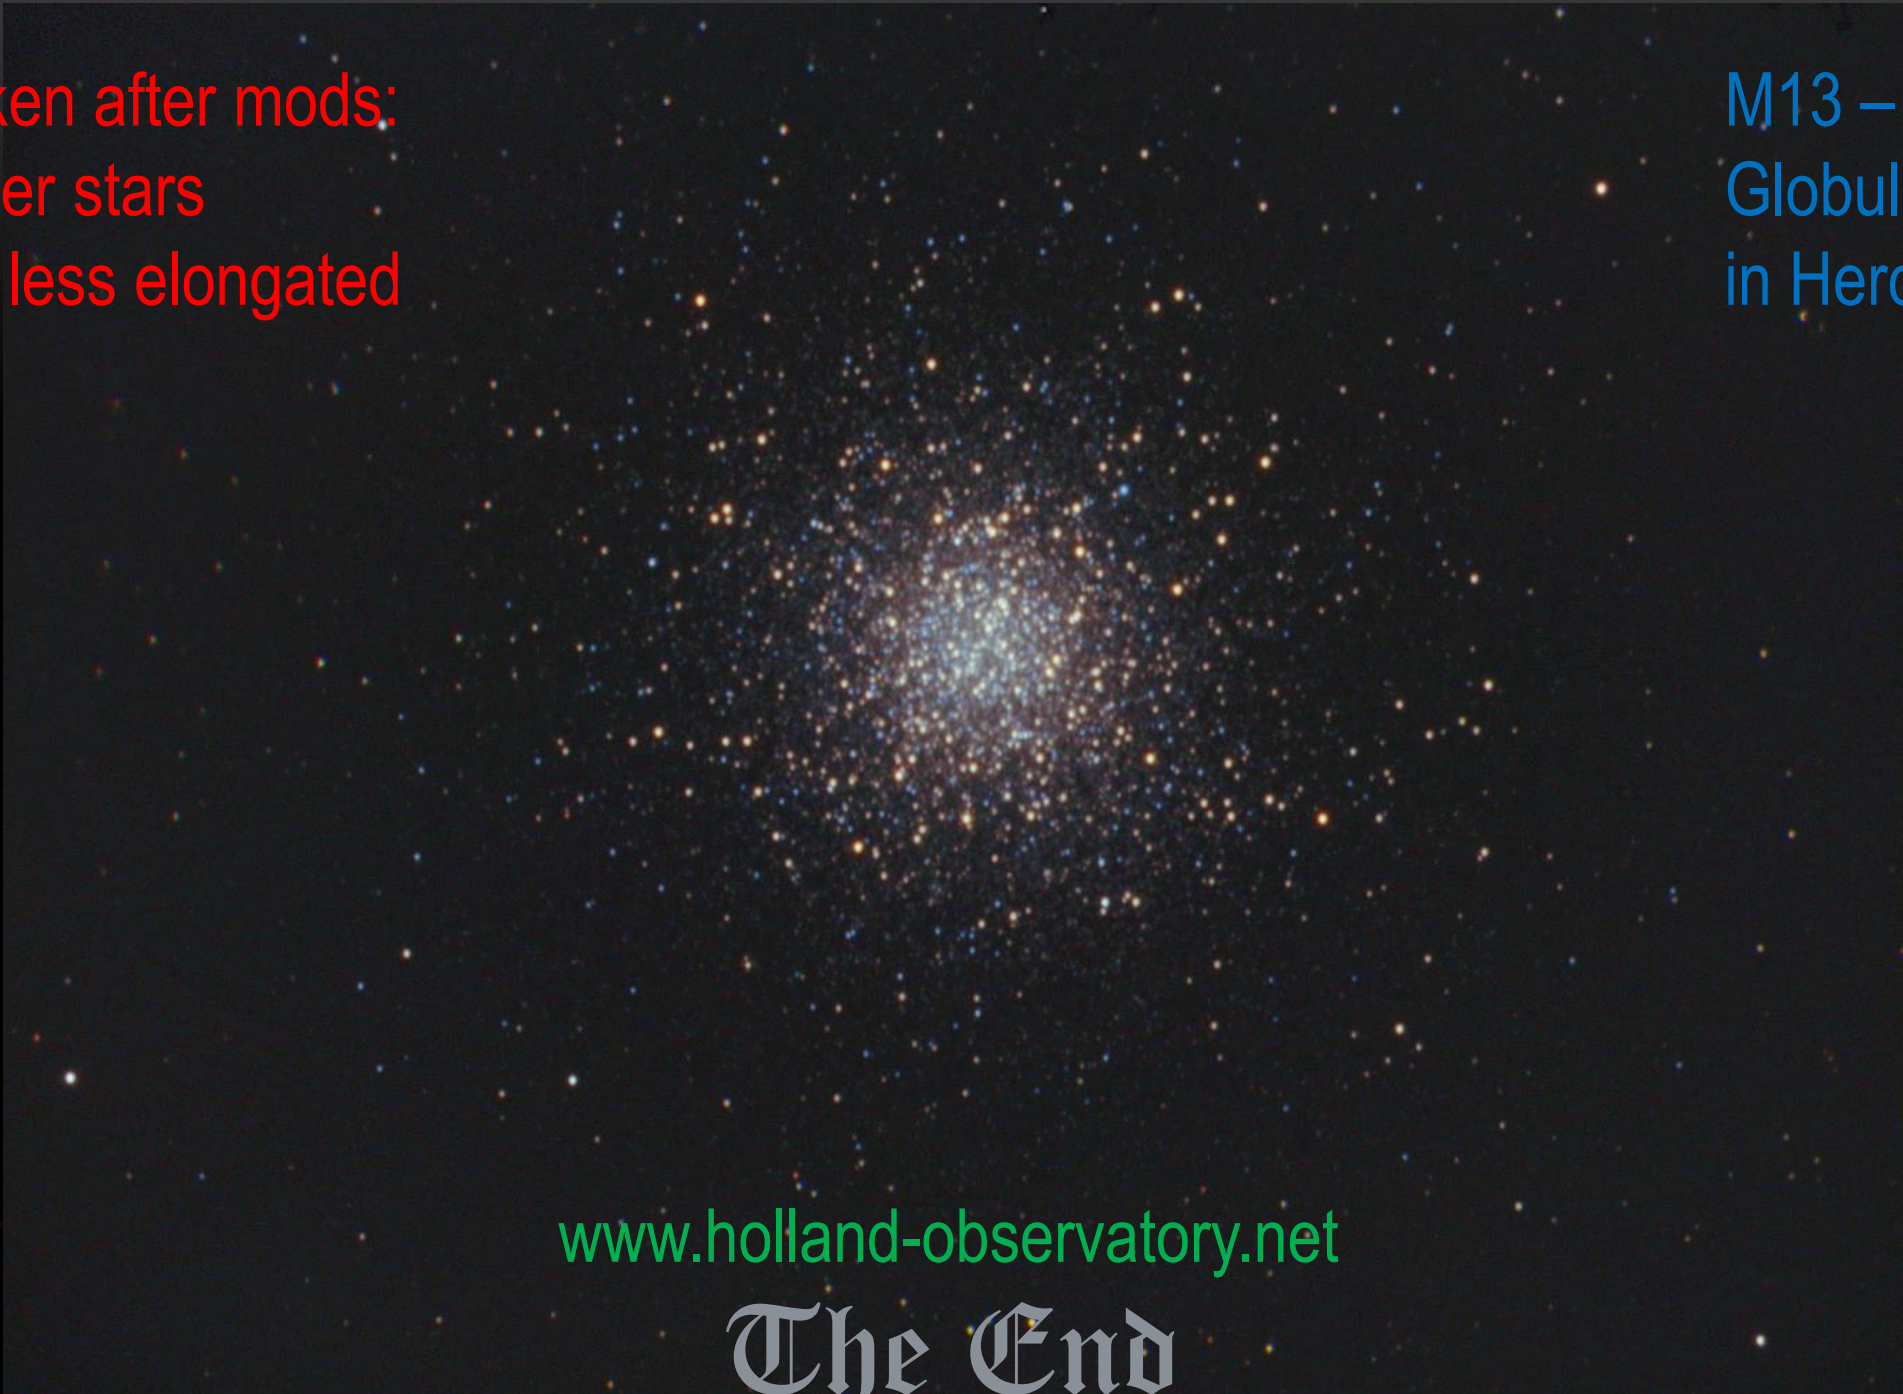
M13 –
Globular Cluster
in Hercules

Image taken after mods:

1. Smaller stars
2. Stars less elongated
